LAMBOURNE ENVIRONMENTAL Ltd.

Re: Nakusp, BC – Lagoon Survey report

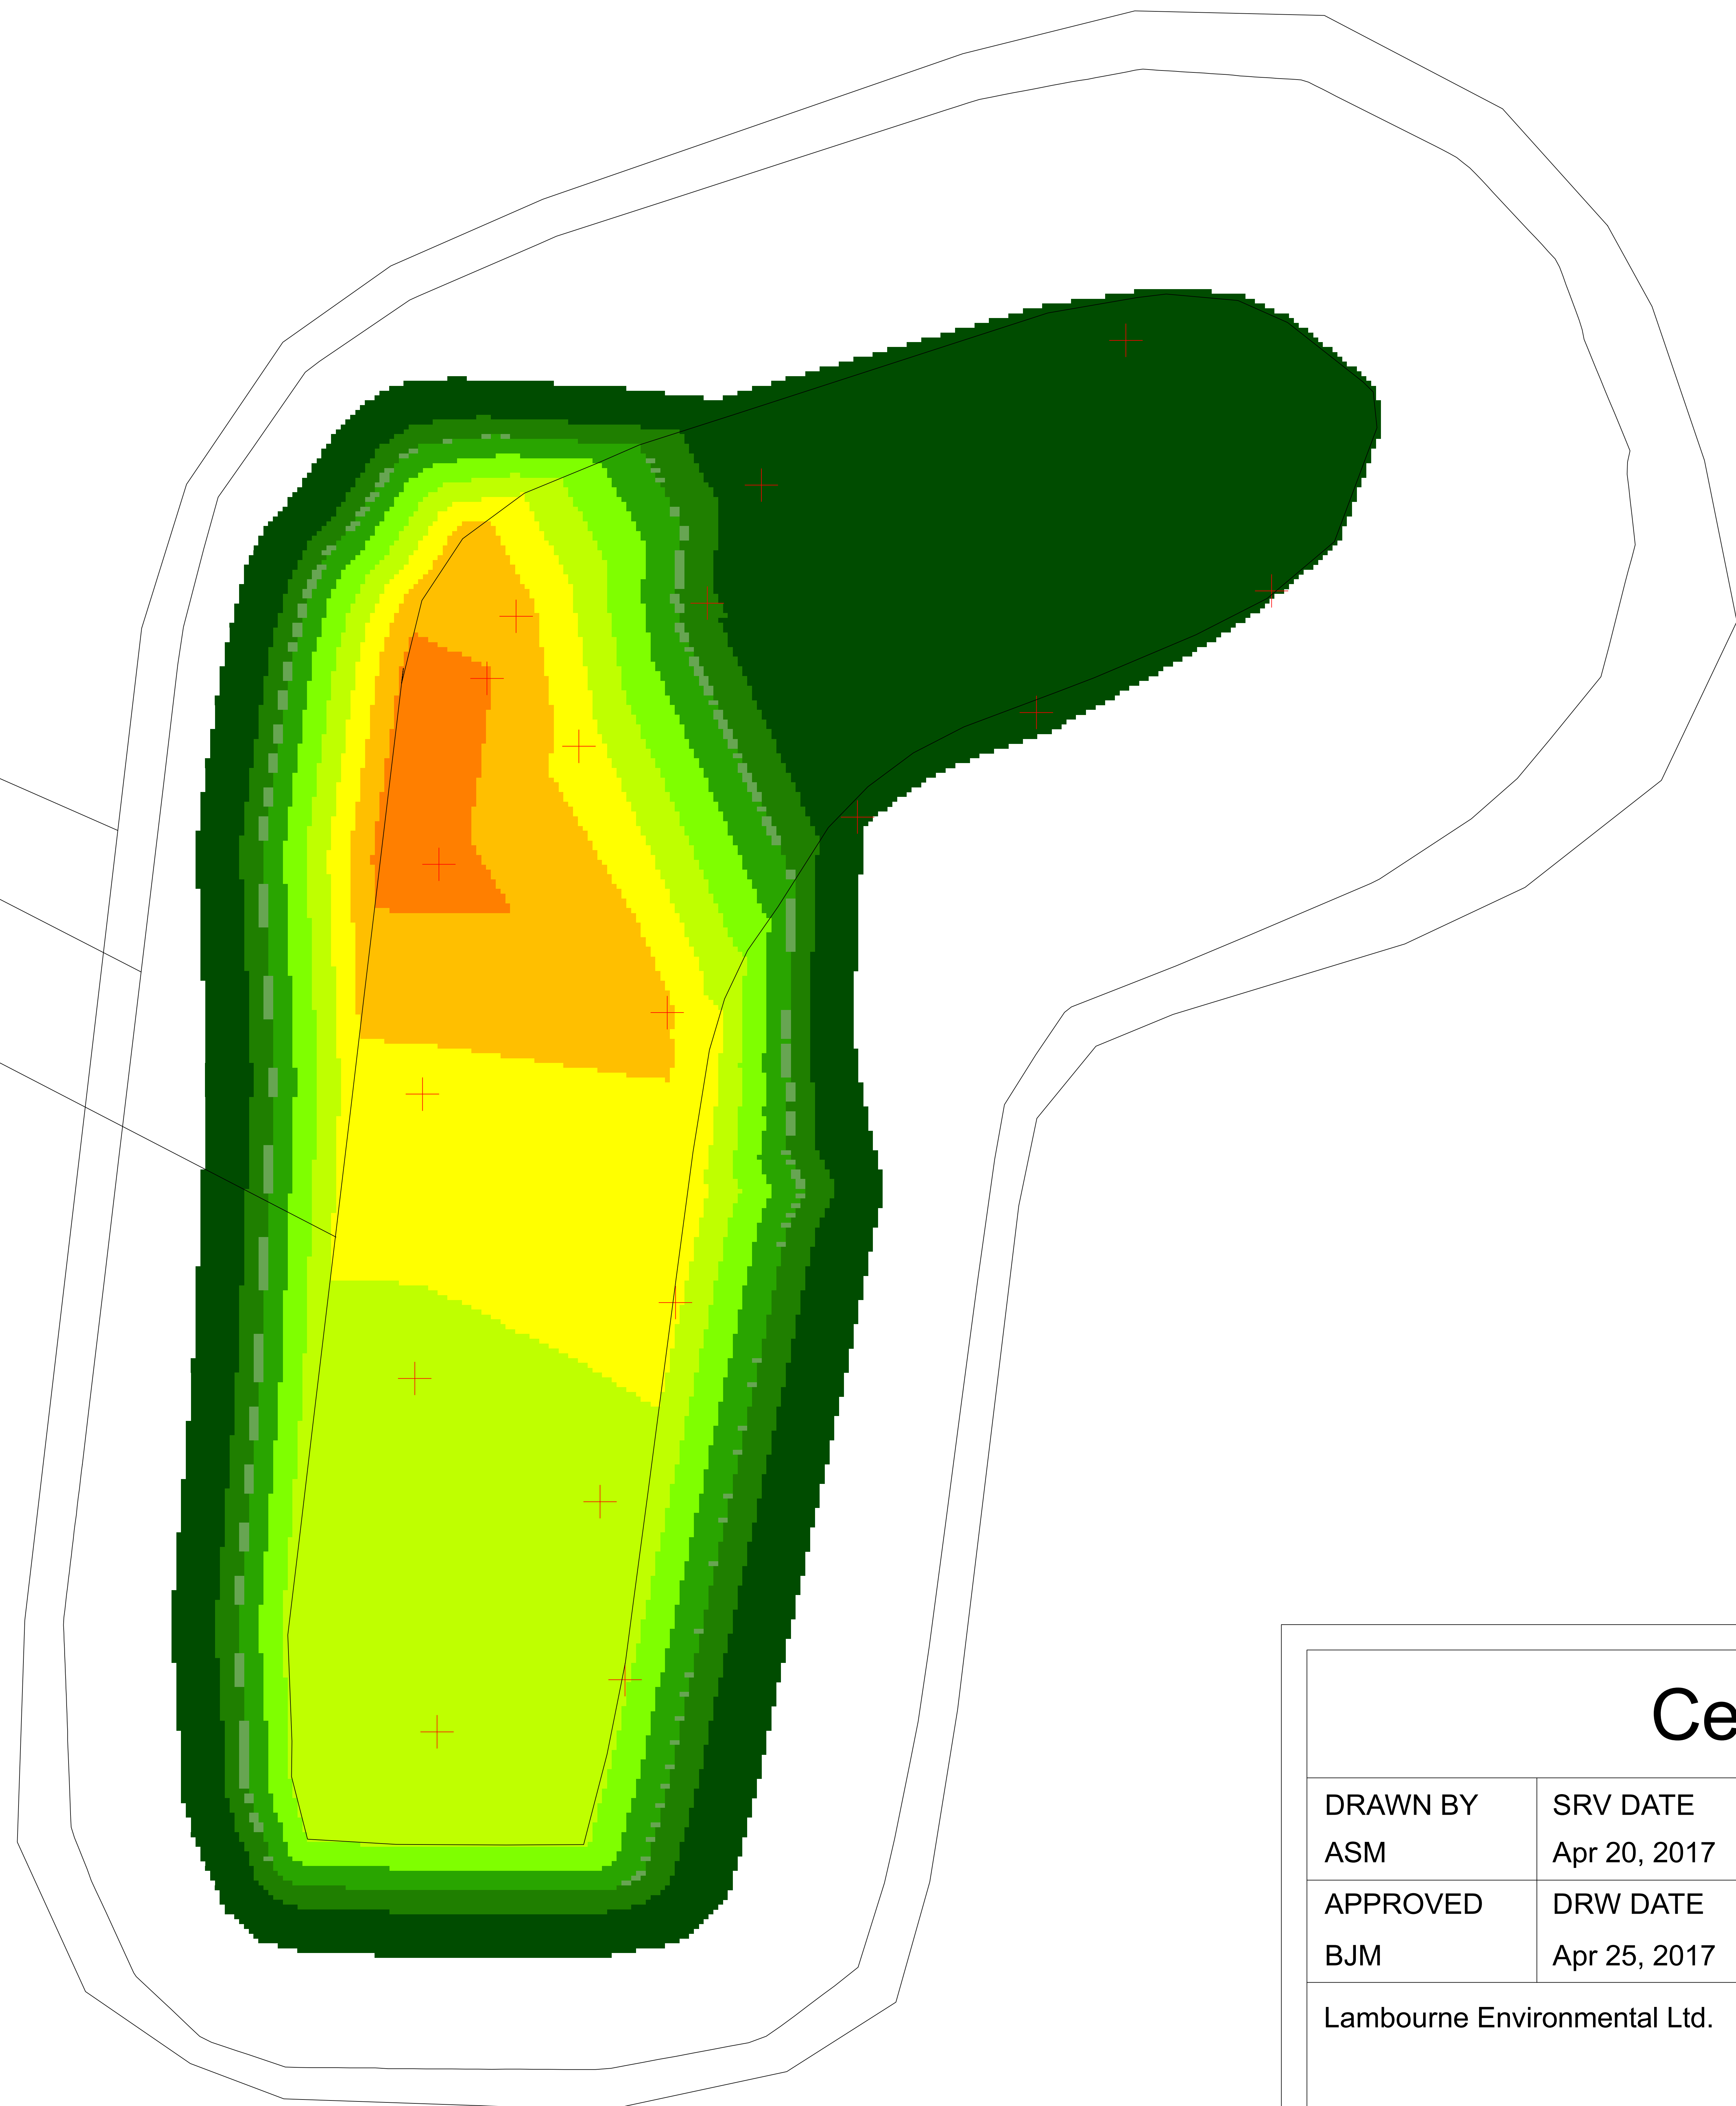
Cell	Total Volume (m ³)	Sludge Volume (m ³)	Total Depth (m)	Max Sludge Depth (m)	Average Sludge Depth (m)	Berm Slope Used
Cell 1	1,700	90	3.20	0.81	0.30	3:1
Cell 2	9,500	3,500	3.40	2.80	1.24	See site overview drawing

We would recommend that cell 1 does not require desludging and that cell 2 should be desludged as there was considerable buildup at the south end of the cell.
