**N A K U S P**

# **2013 Annual Water Report**

**Public Works Department**

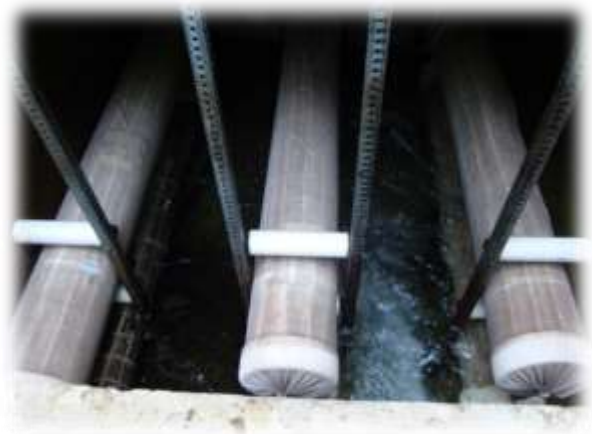
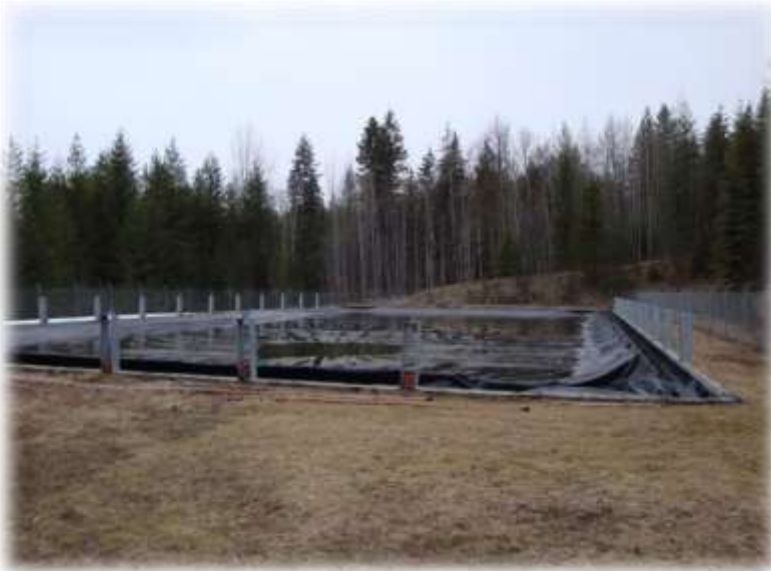
Surface water undergoes course filtration in the Filter Sock Chamber, which houses six perforated PVC pipes covered with mesh filter media (socks). Each pipe is approximately 12" in diameter and 8' long.

Course filtration removes large debris, such as leaves, sticks, pine needles, frogs, etc. These filter socks become clogged, especially during the freshet and require monitoring and cleaning. Course filtration is not technically considered a treatment process, as fine materials and micro-organisms are not removed, therefore, chlorination is required.

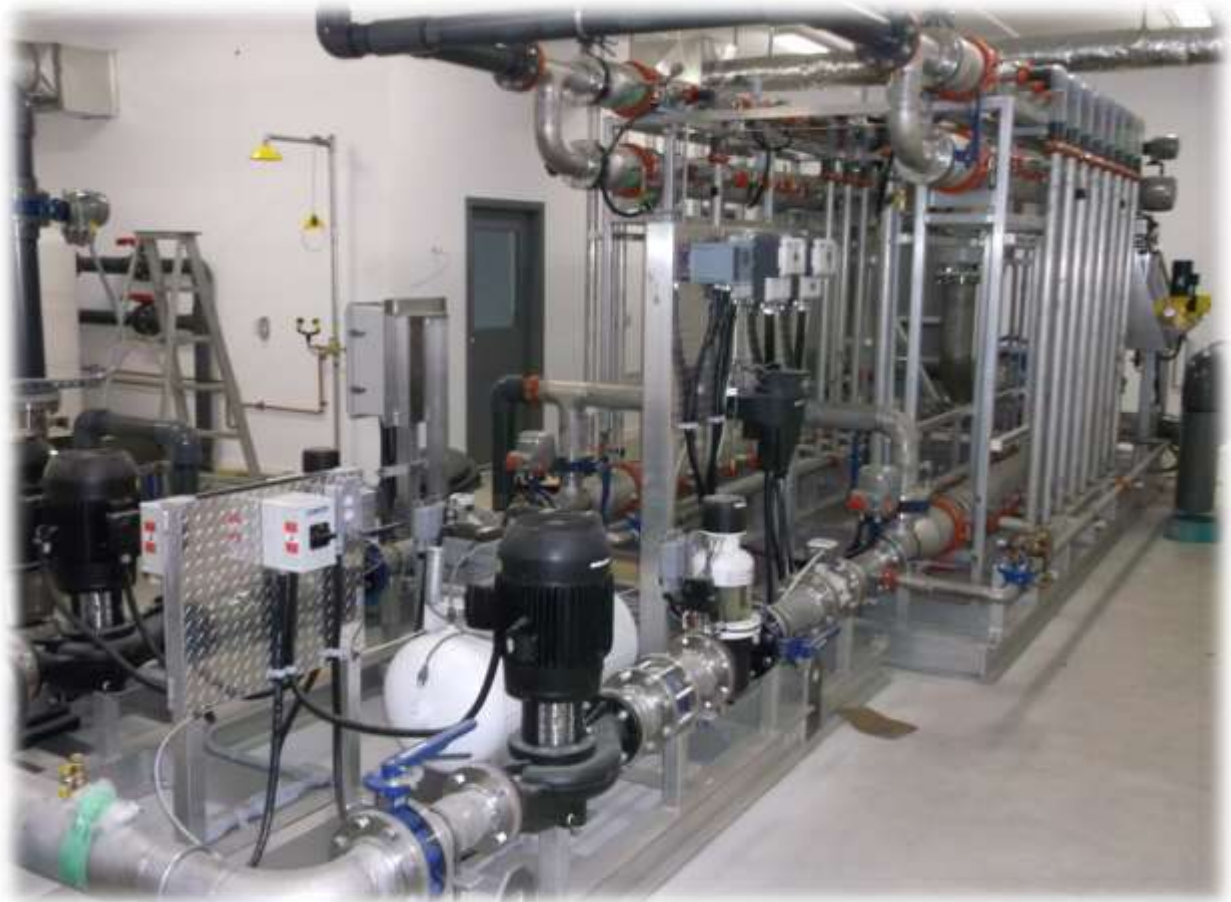
The Village is currently working on the construction, installation and implementation of a new water treatment plant facility and Micro Hydro generation station. These facilities should be up and running in the new year.
